GRAVITY SEWER REPAIR  
MARINE DRIVE  
CONSTRUCTION COMPLETION REPORT

*PREPARED*  
OCTOBER 9, 2001

CITY OF BLAINE, PUBLIC WORKS DEPARTMENT  
1200 YEW AVENUE  
BLAINE, WA 98230

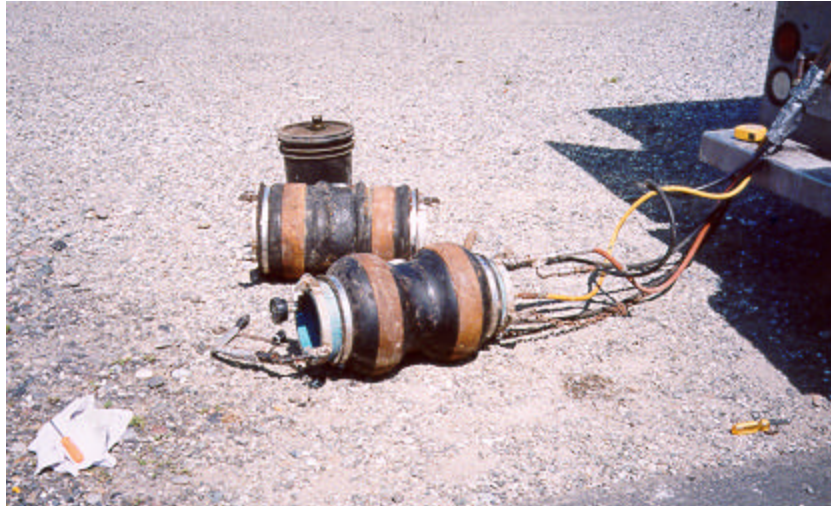
Figure 1. - Joint seal and pressure test device (August 2001).  
*Photo by Jon Walter*

Pipe joints were sealed by epoxy injection followed by a pressure test to confirm the repair. Figure 1. below shows the equipment that GELCO used to make these joint improvements.

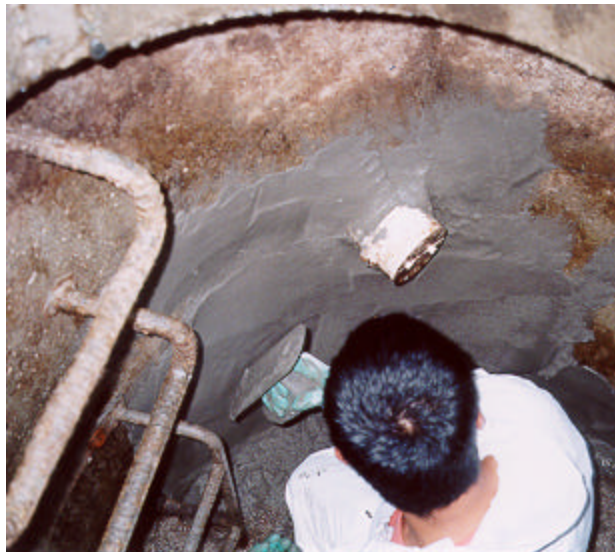
Figure 2. – Trowel application of patching material in manhole on Marine Drive (August 2001).  
*Photo by Jon Walter*

The manhole patching that GELCO completed involved trowel application of a cementacious mastic material as shown in Figure 2 below.

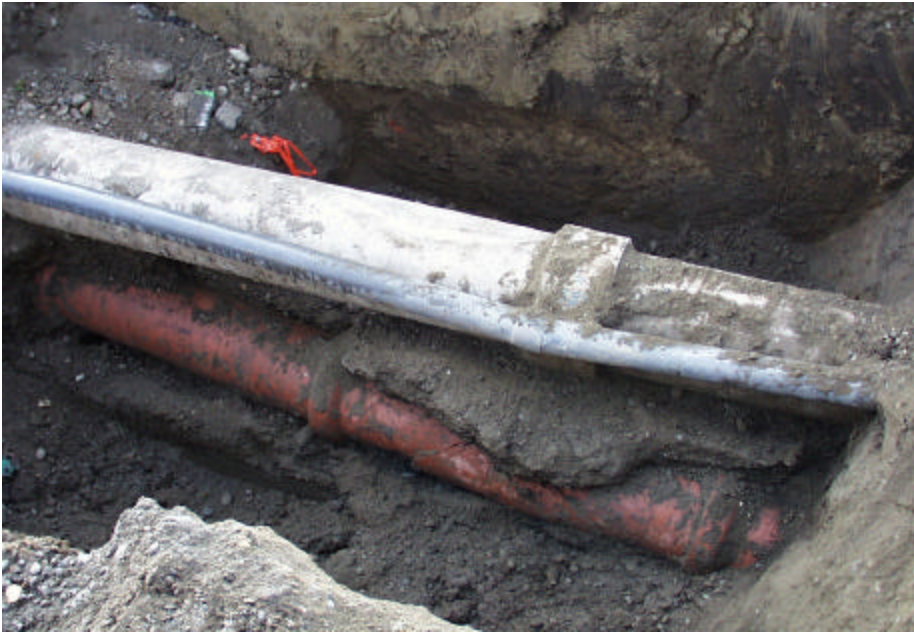
The photograph in Figure 3 below shows a water pipe (gray) and parallel electrical conduit above a broken segment of clay sewer pipe (red) below. We determined that the damage to one of the sewer pipe section was caused in part by a large concrete block between the pipes, probably installed to support the water pipe joint above. The concrete was removed and the damaged pipe replaced with new PVC pipe (Figure 4). The excavation was then filled with pea gravel. In one of the other areas repaired by Public Works, a remnant of wooden pilings (probably from an old trolley line) was found directly below the clay sewer pipe causing differential settlement and damage to the pipe. Prior to replacing the broken pipe section, the public works crew removed the top 12" or so of the remnant piling. Roadside surfaces were restored with compacted crushed gravel.

Figure 3.  
On Marine Drive,  
broken 12"  
diameter clay  
sewer pipe below  
water pipe and  
electrical conduit.  
(September 2001)  
*Photo by Jon  
Walter*

Pipeline replacement was completed by City of Blaine, Public Works by open cut excavation. Broken clay and concrete pipe sections were removed and replaced with new PVC-900 pipe. The ends of the new pipe were fastened to the existing pipe with banded (FERNCO brand) couplings.

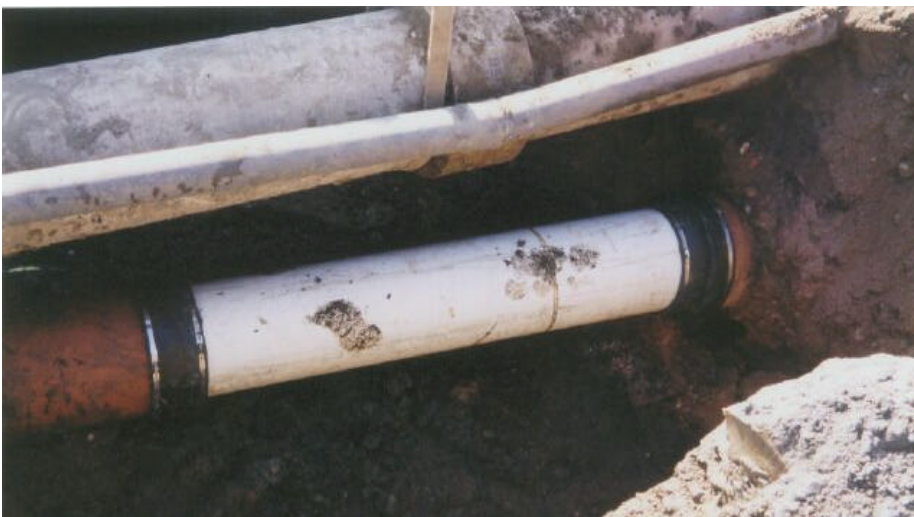
Figure 4.  
On Marine Drive,  
12" sewer pipe  
repairs completed  
by Public Works  
(September 2001)  
*Photo by Jon  
Walter*

- Manhole D3-1 to C3-5: one repair of break 128' to 130'
- Manhole D3-1 to C3-5: two back to back repairs of break from 153' to 160'
- Manhole C3-2 to C3-1: two back to back repairs of break from 78' to 83'
